Healing a panniculus wound

Cardinal Health™ SVED® device¹ with simultaneous irrigation healed a chronic panniculus wound complicated by necrotizing fasciitis

Case study **2**

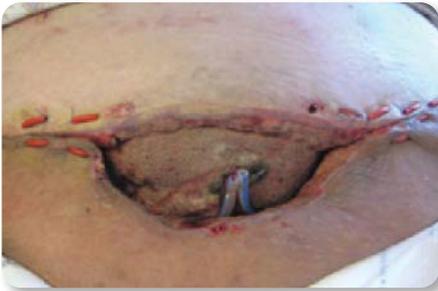
Figure 1A

- Post-surgical view
- Closure of all but 56 cm of wound

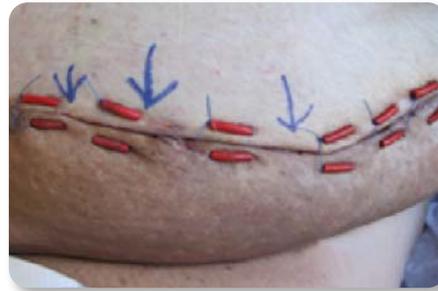
Figure 1B

- Post-surgical view
- Sutured wound edges not adhered
- Tunnel depth: 5 to 10 cm

Initial wound assessment found no adhesion of sutured wound edges. Tunneling under the sutures extended 51 cm to the right and to the left of the central open wound. Tunnel depth ranged from 5 to 10 cm. The long term acute care wound care team noted a moderate amount of thick serosanguinous drainage from the base of the midline wound and emerging between openings in the suture line.

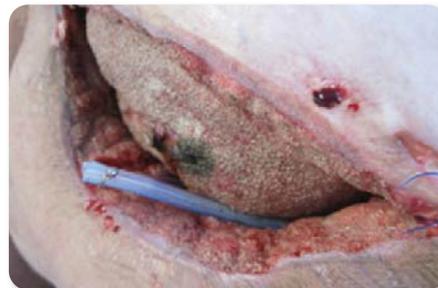
Figure 1C

- Post-surgical view
- Surgical drain

To promote moist wound healing, the team managed exudates by irrigating wound tunnels with normal saline, and controlled absorption by using Hydrofiber® Technology² and alginate.

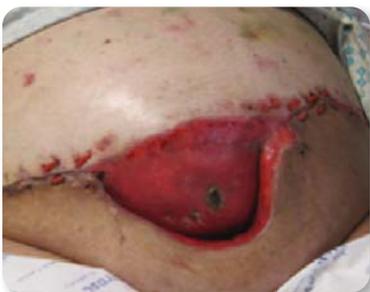
Figure 2A

- Open wound: 56 x 36 cm
- Granulated tissue; no adhesion of sutured wound edges
- Tunnel length: 35 cm/track
- Tunnel depth: 5 to 10 cm

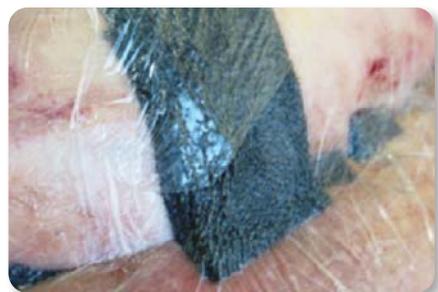
Figure 2B

- Same wound after negative pressure wound therapy was set-up with simultaneous irrigation

On day 28, the wound care team removed the surgical drains, as they had become non-functional. The team initiated negative pressure wound therapy with simultaneous irrigation: The Cardinal Health™ SVED® device.

- **Tunneling:** The team placed Cardinal Health™ White Foam Dressing 5 cm into the tract on each side, and Cardinal Health™ Black Foam Dressing in the central wound defect. This arrangement facilitated the flow of irrigation solution into the area of tunneling, and then — propelled by negative pressure wound therapy — allowed the solution to exit the wound

- **The periwound skin** was protected with hydrocolloid strips, and a thin strip of Cardinal Health™ Black Foam was placed over the suture line. This prevented irrigation solution and drainage from seeping through gaps in the sutures

- **Bioburden:** The team reduced bioburden using Prontosan® Wound Irrigation Solution.³
Irrigation protocol was as follows:
 - Days 1 to 4: Continuous drip infusion; intermittent pressure at -150 mmHg

- Day 5 to end of therapy: 20 cc bolus administered twice a day; continuous pressure at -150 mmHg
- **Negative Pressure Wound Therapy with simultaneous irrigation:** All components were managed with the Cardinal Health™ SVED® device

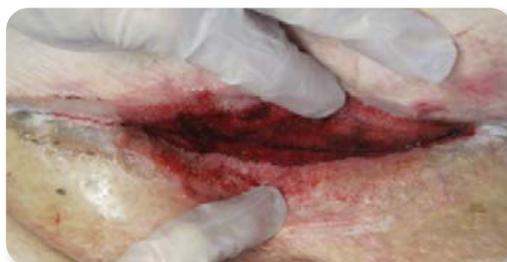
Figure 3

- 56 x 13 x 2 cm
- Wound immediately prior to final closure by wound care team

Final closure was performed on-site by the wound care team (advanced practice nurses under the supervision of the team's physician). Although the wound would have closed without any suturing, this uncomplicated procedure made the patient a better candidate for placement in a long term acute care facility.

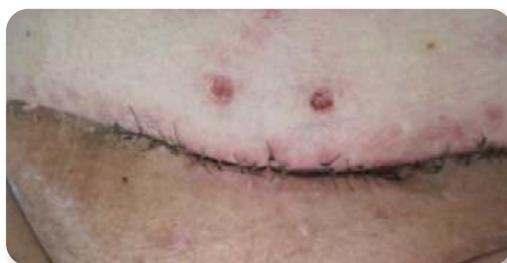
Figure 4

- Total wound recovery

Shortly after this final picture was taken, the patient was discharged to a long term care acute facility in order to treat the neurological complications of her sepsis.
